FINAL REPORT

EVALUATION OF SPACE SHUTTLE MAIN ENGINE BEARINGS
FROM HIGH PRESSURE OXYGEN TURBOPUMP 9008
(Contract No. NAS8-33576 - Task No. 102)

K.F. Dufrane and J.W. Kannel

BATTELLE
COLUMBUS LABORATORIES
505 KING AVENUE
COLUMBUS, OHIO 43201

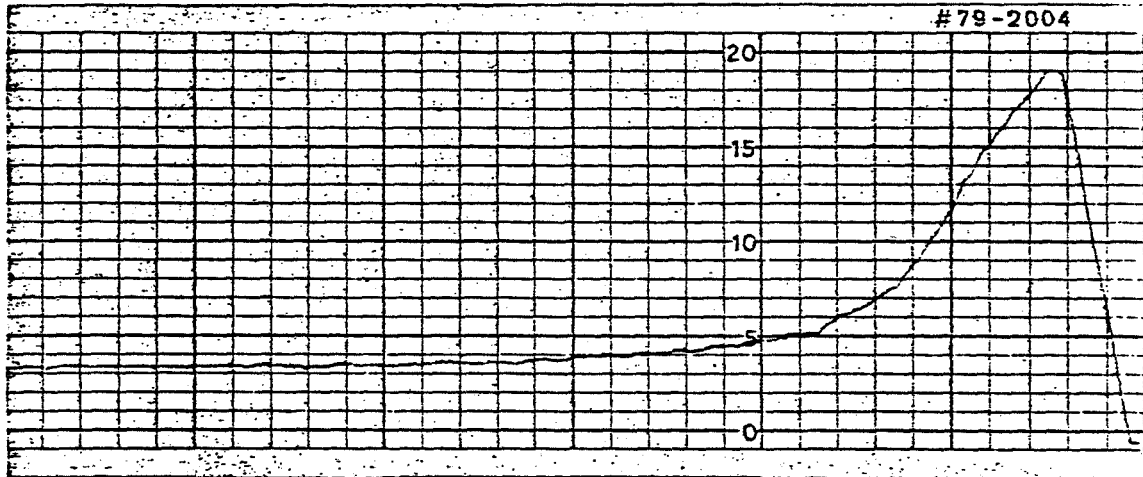
FIGURE 2. PROFILE OF BURR AT EDGE OF RACE CURVATURE ON
INNER RACE OF BEARING S/N 8519531.
Magnifications: Vertical, each small division =
0.0051 mm (0.0002 inch); Horizontal, each small
division = 0.051 mm (0.002 inch)

Cross-race curvature measurements at the extremes of the variation in track location confirmed the material removal. As shown in Figure 3, the wear depth at the shoulder varied from approximately 0.15 mm (0.006 inch) to 0.10 mm (0.004 inch). Since the burr at the edge, shown in Figure 2, does not have a volume sufficient to account for the material loss on the race, the loss occurred by wear.

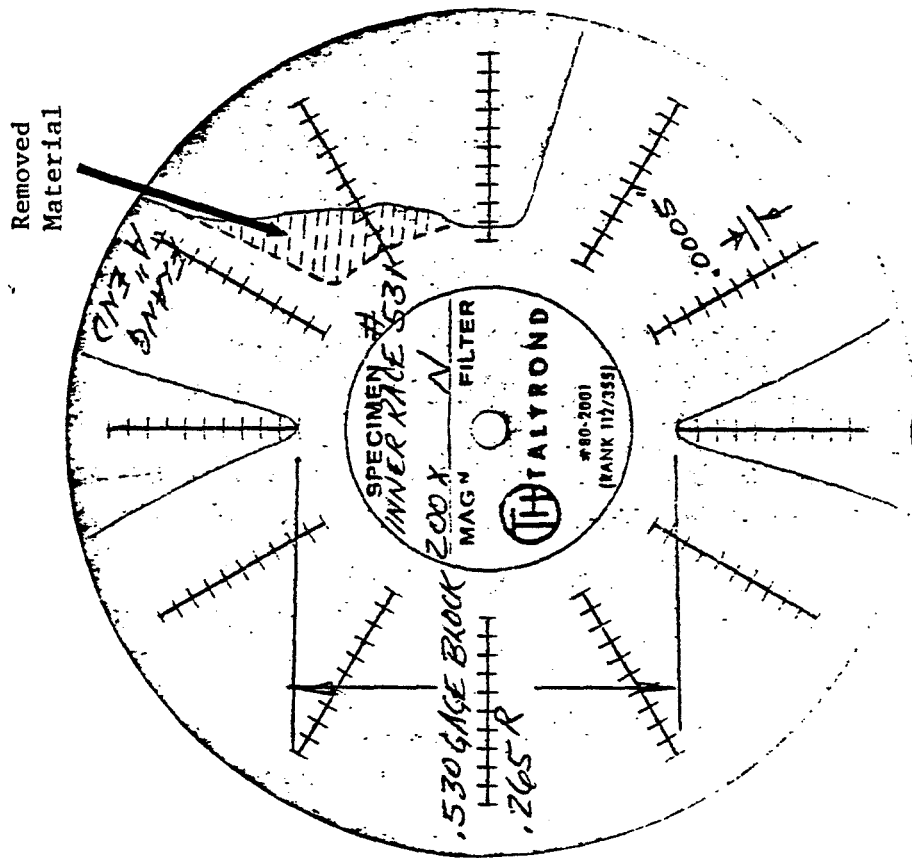
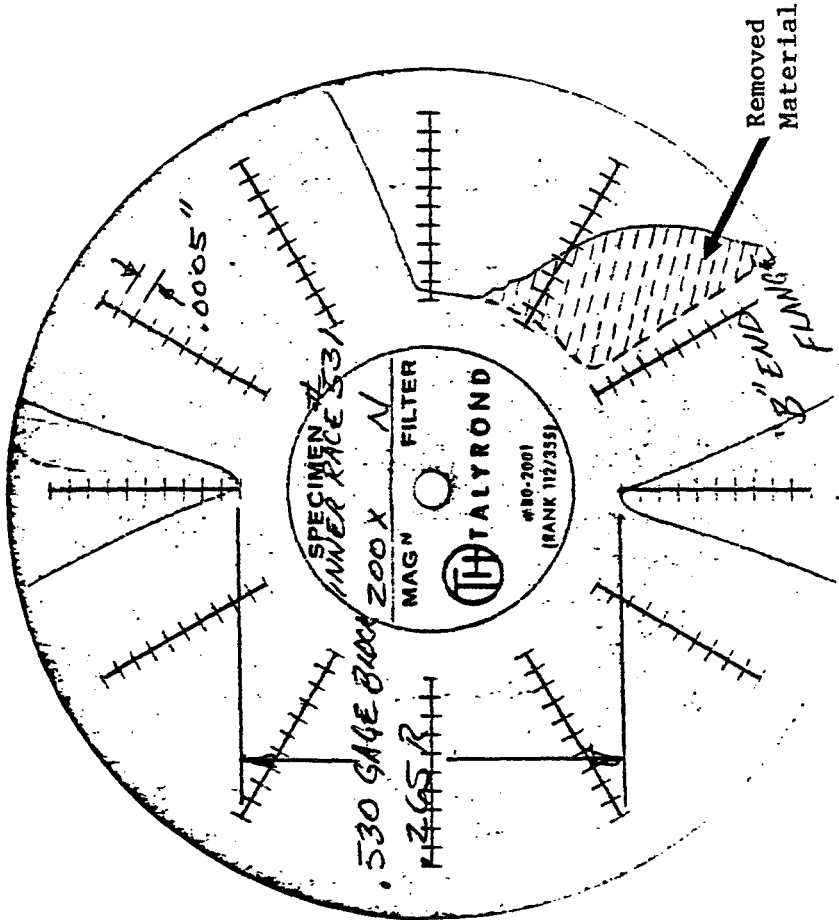
FIGURE 3. INNER RACE CROSS-RACE CURVATURES TAKEN AT POSITIONS 180 DEGREES APART ON BEARING S/N 8549531. Radial Magnification: 1 division = 12.7 μ m (.0005 inch)

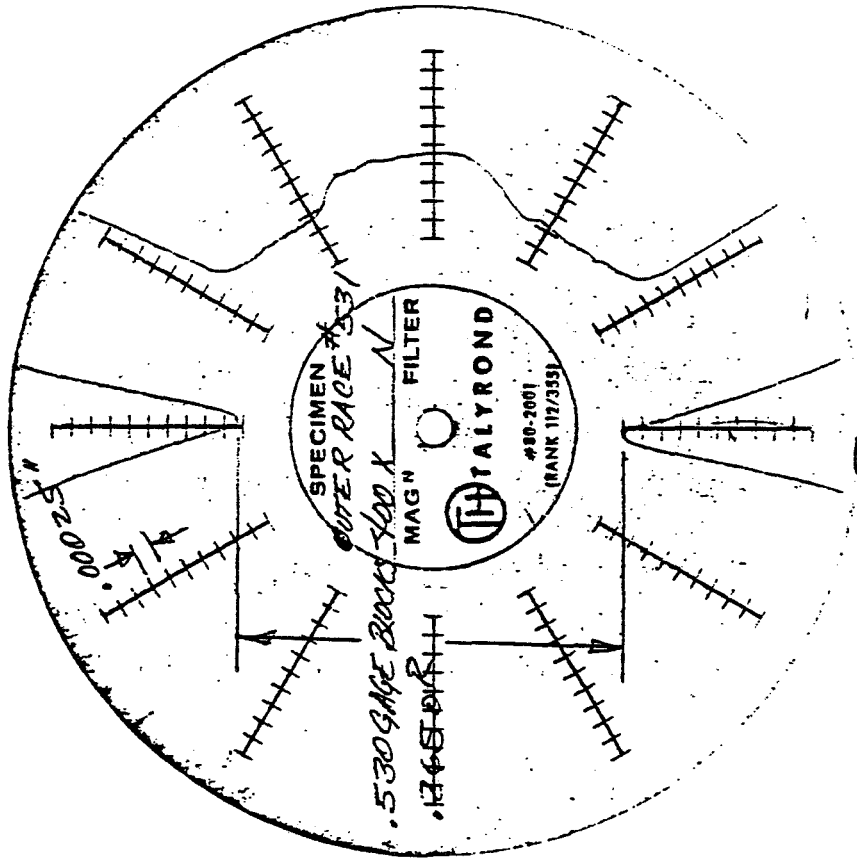
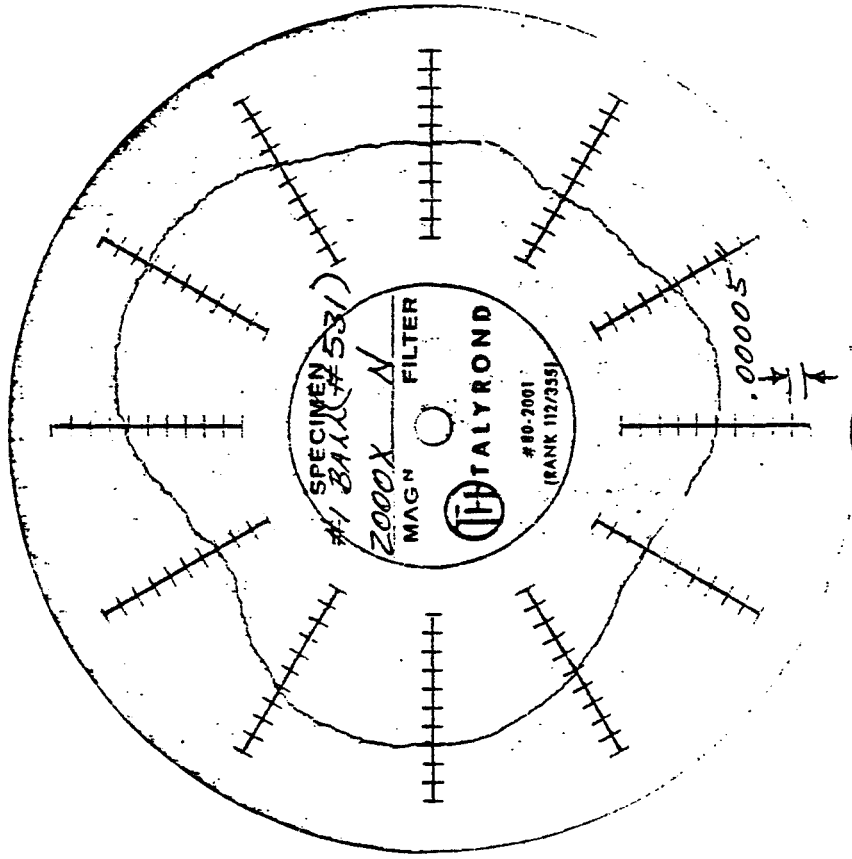
Cross-race curvature measurements with a Talyrond revealed a centrally located circumferential groove in the race approximately 0.013 mm (0.0005 inch) deep, Figure 4(a). This groove was not centered on the band of spalling, but did include a portion of it. Apparently it was also primarily the result of wear, similar to the wear bands on the inner race.

FIGURE 4. OUTER RACE CROSS-RACE CURVATURE AND TYPICAL NON-SPALLED BALL ROUNDNESS
FROM BEARING S/N 8549531

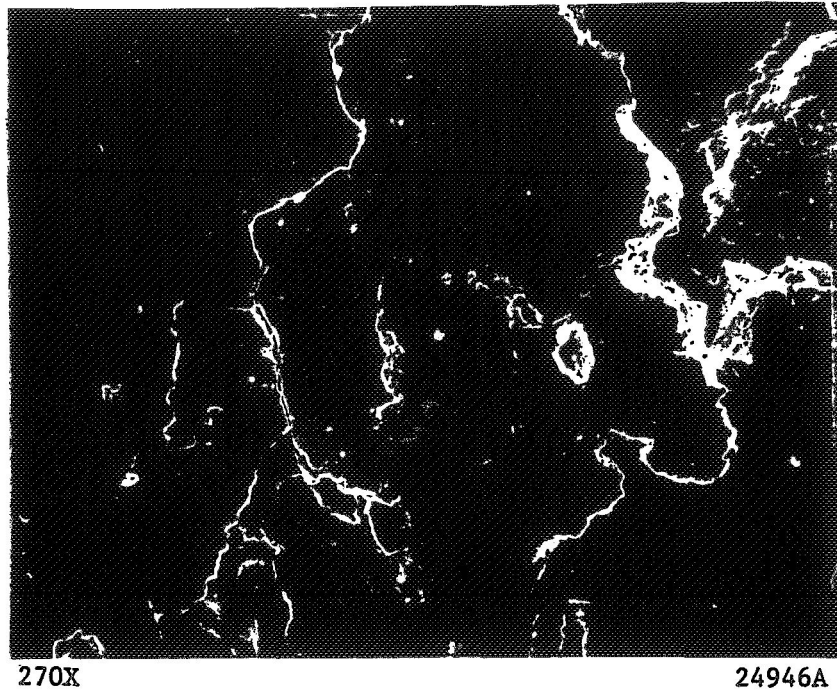
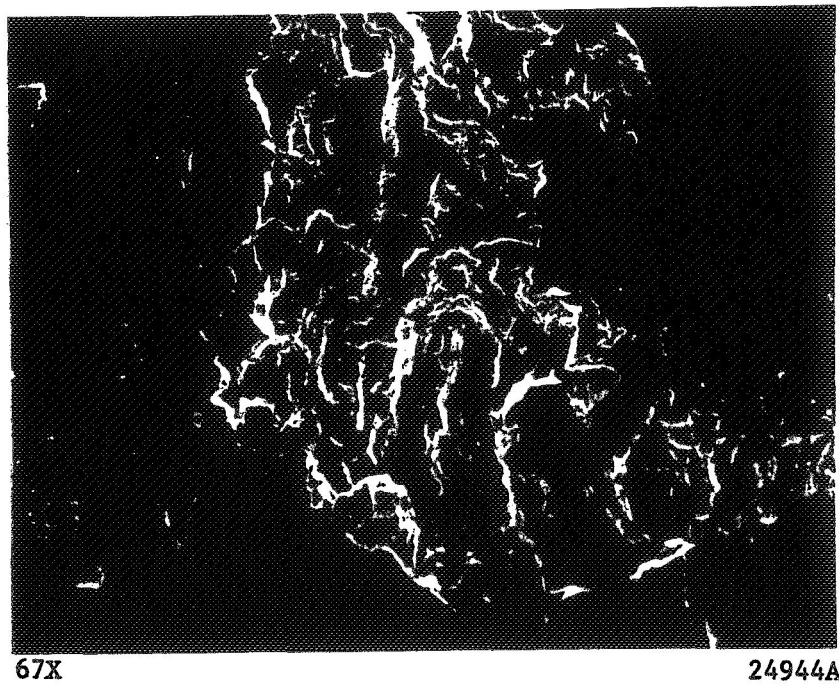
Observation of the races by scanning electron microscopy (SEM) revealed the pits to be jagged and steep sided, Figures 5 and 6(b). Such pits on bearing races are characteristic of fatigue spalls.

FIGURE 5. SCANNING ELECTRON MICROGRAPHS OF SURFACE
SPALLING ON INNER RACE OF BEARING
S/N 8519531

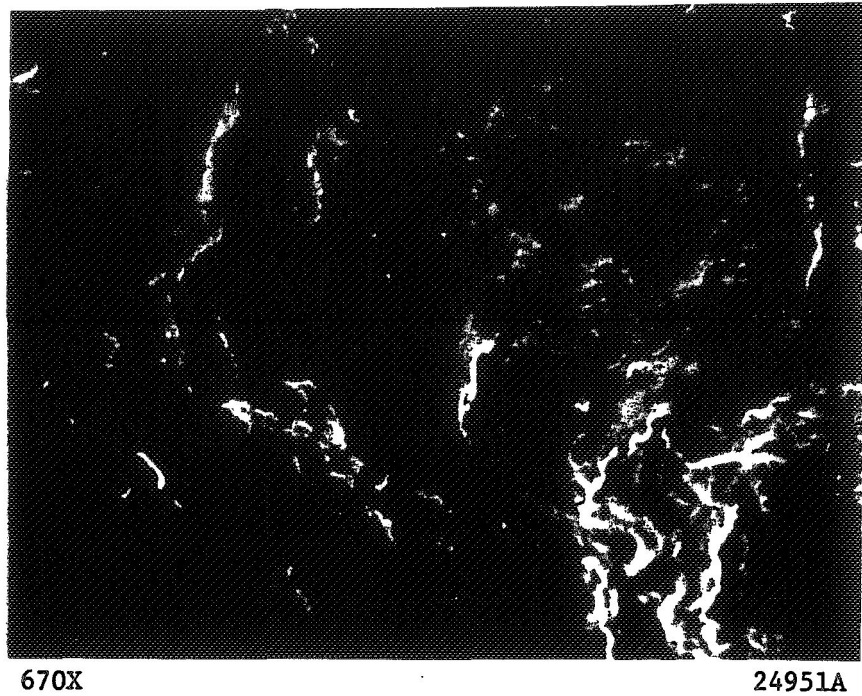
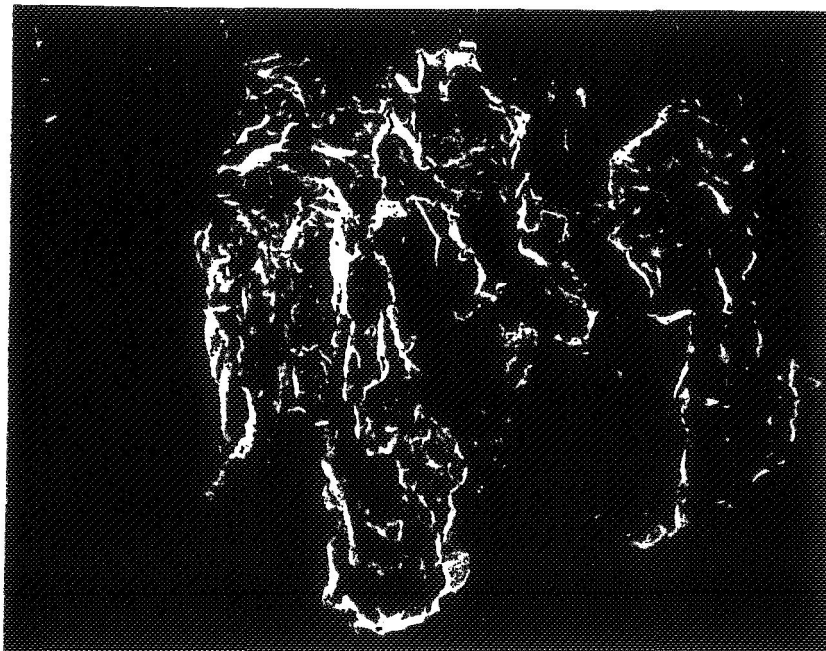
FIGURE 6. SPALLING ON BALL AND OUTER RACE SURFACES OF BEARING S/N 8519531

Since only half of each race and six of the thirteen balls were supplied for inspection, a complete assessment of the damage could not be made. Of the six balls received, one had a small spalled area, one had a large spalled area, and four were relatively smooth. A spalled region of one of the balls is shown in Figure 6(a), and a Talylrond trace of an unspalled ball is shown in Figure 4(b). Ball damage is expected after race spalling occurs, and the damage observed on the balls was not considered to be extensive in view of the heavy race spalling and wear.

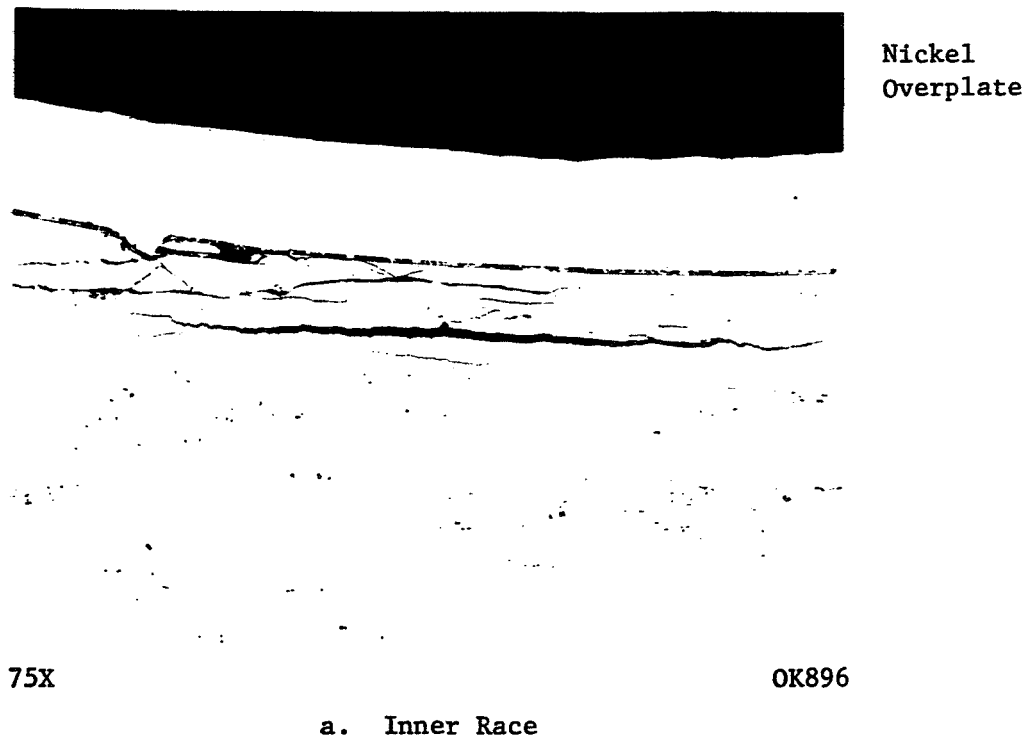
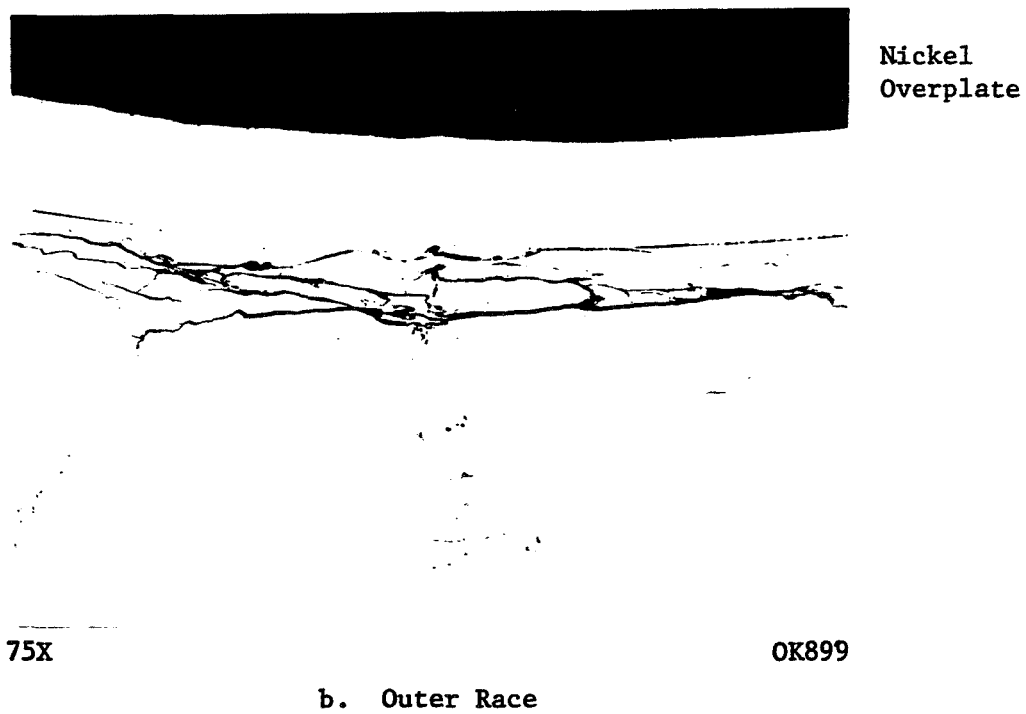
Metallographic sections of the races revealed that the subsurface damage was much more extensive than apparent by the spalls at the surfaces. Examples are shown in Figure 7 of the widespread subsurface cracking below the relatively small fatigue pits at the surface. The depth of the major cracks was approximately 0.14 mm (0.005 inch).

FIGURE 7. SUBSURFACE CRACKING ON RACES OF BEARING S/N 8519531

Fatigue life is heavily related to the shear stresses generated beneath the bearing surfaces. This shear stress reaches a maximum at a depth of 0.5 times the half-width of the ball-race contact region. For the 44,500 N (10,000 pounds) condition, this depth is about 0.16 mm (0.007 inch), while for the condition of 3800 N (850 pounds) axial load combined with 8900 N (2000 pounds) radial load, this depth is about 0.13 mm (0.005 inch). A section photomicrograph for the bearing S/N 8549531 presumed to have experienced this load is given in Figure 7. The maximum crack depth from this Figure was 0.13 mm (0.005 inch), which correlates quite well with the

predictions. Continued operation on this bearing would lead to massive removal of race material from this cracked region. These cracks would doubtless be the source of advanced failure of the bearing.

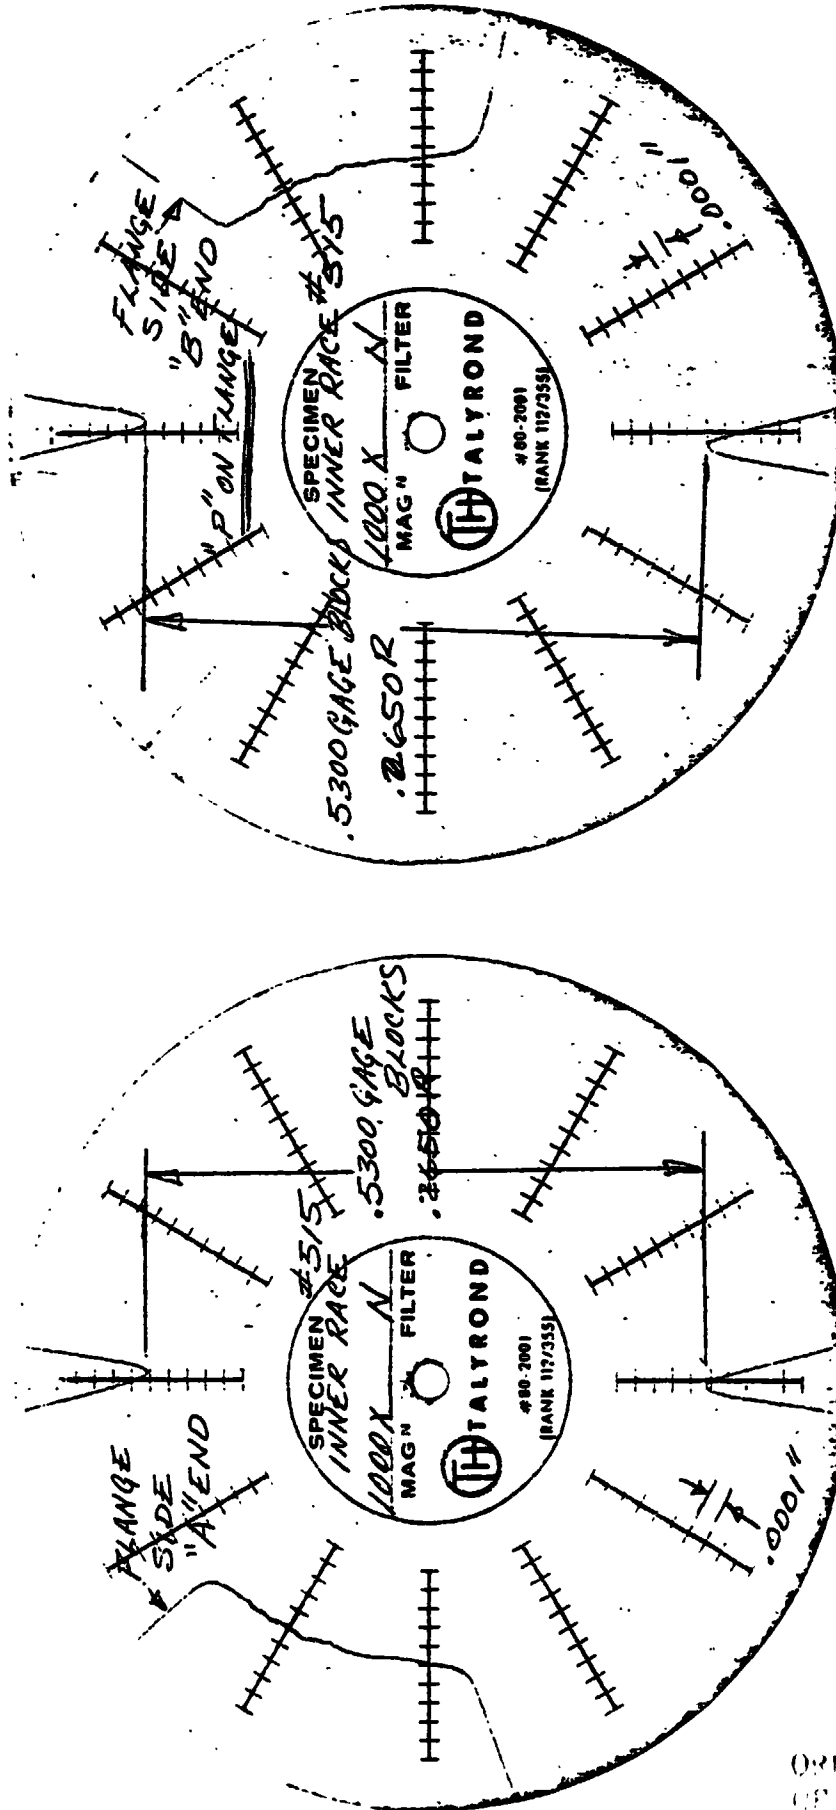
Talyrond cross-race curvature measurements, shown in Figures 10 and 11(a), confirm the mild and uniform wear. A graphical illustration of the ball contact paths is presented in Figure 14 as part of the load-estimate calculations.

FIGURE 10. INNER RACE CROSS-RACE CURVATURES TAKEN AT POSITIONS 180 DEGREES APART ON BEARING S/N 8549414. Radial Magnification: 1 division = 2.54 μm (100 microinches)

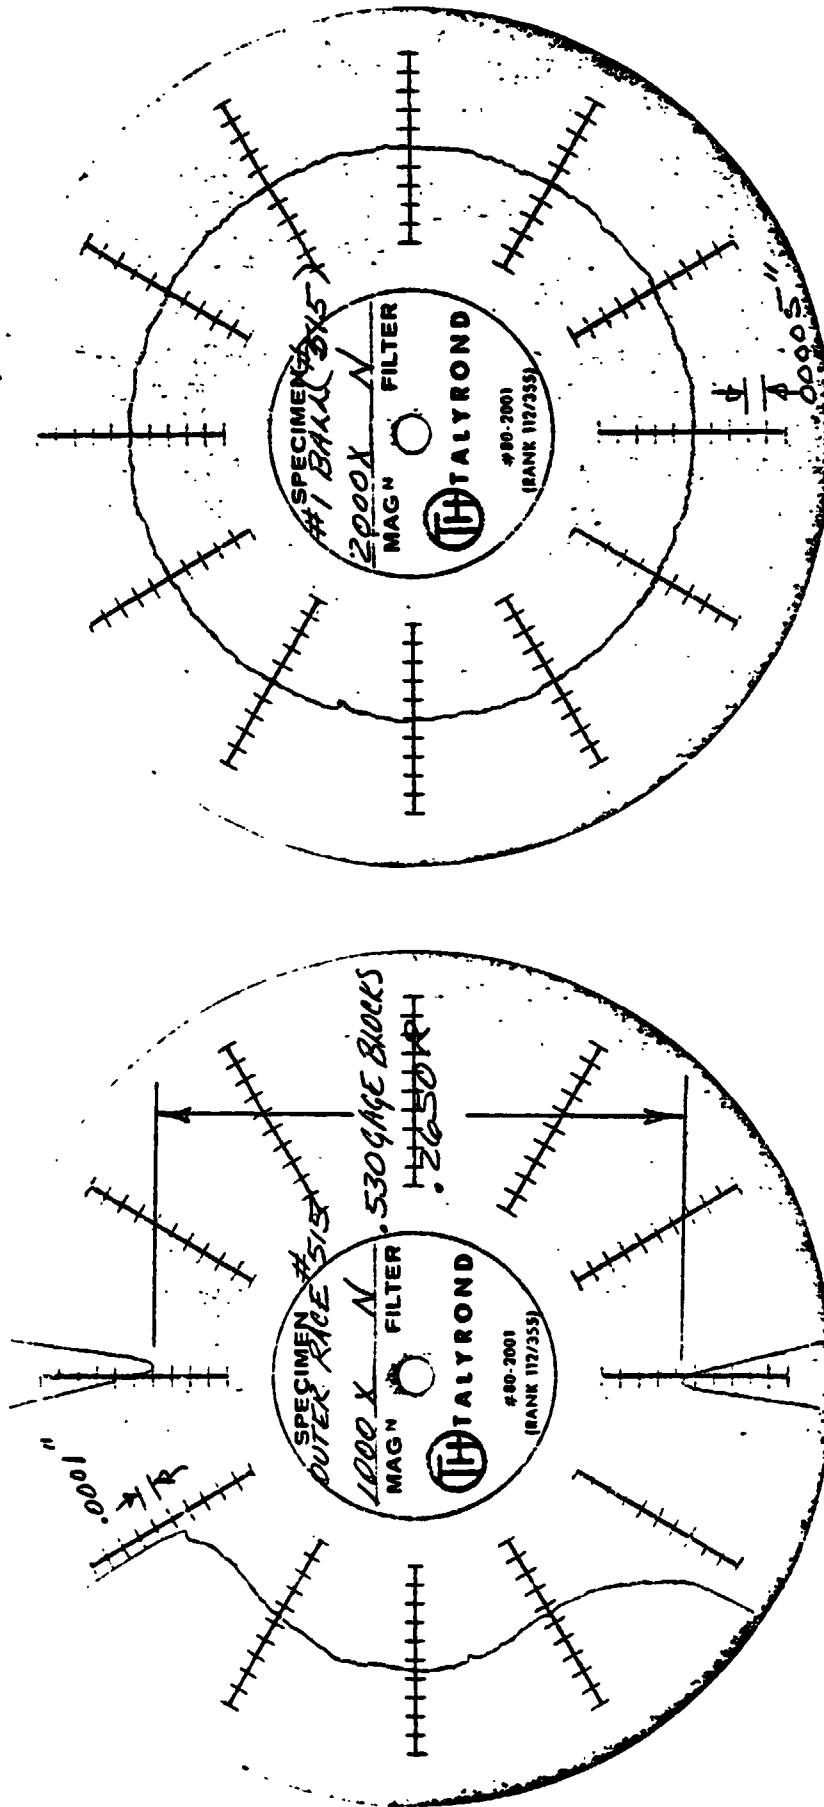
The balls had no apparent wear. The only evidence of contact was in the form of mild color bands. The Talyrond trace in Figure 11(b) of a typical ball confirmed the mild wear and demonstrated the excellent conformity to roundness.

FIGURE 11. OUTER RACE CROSS-RACE CURVATURE AND TYPICAL BALL ROUNDNESS FROM BEARING S/N 8549515

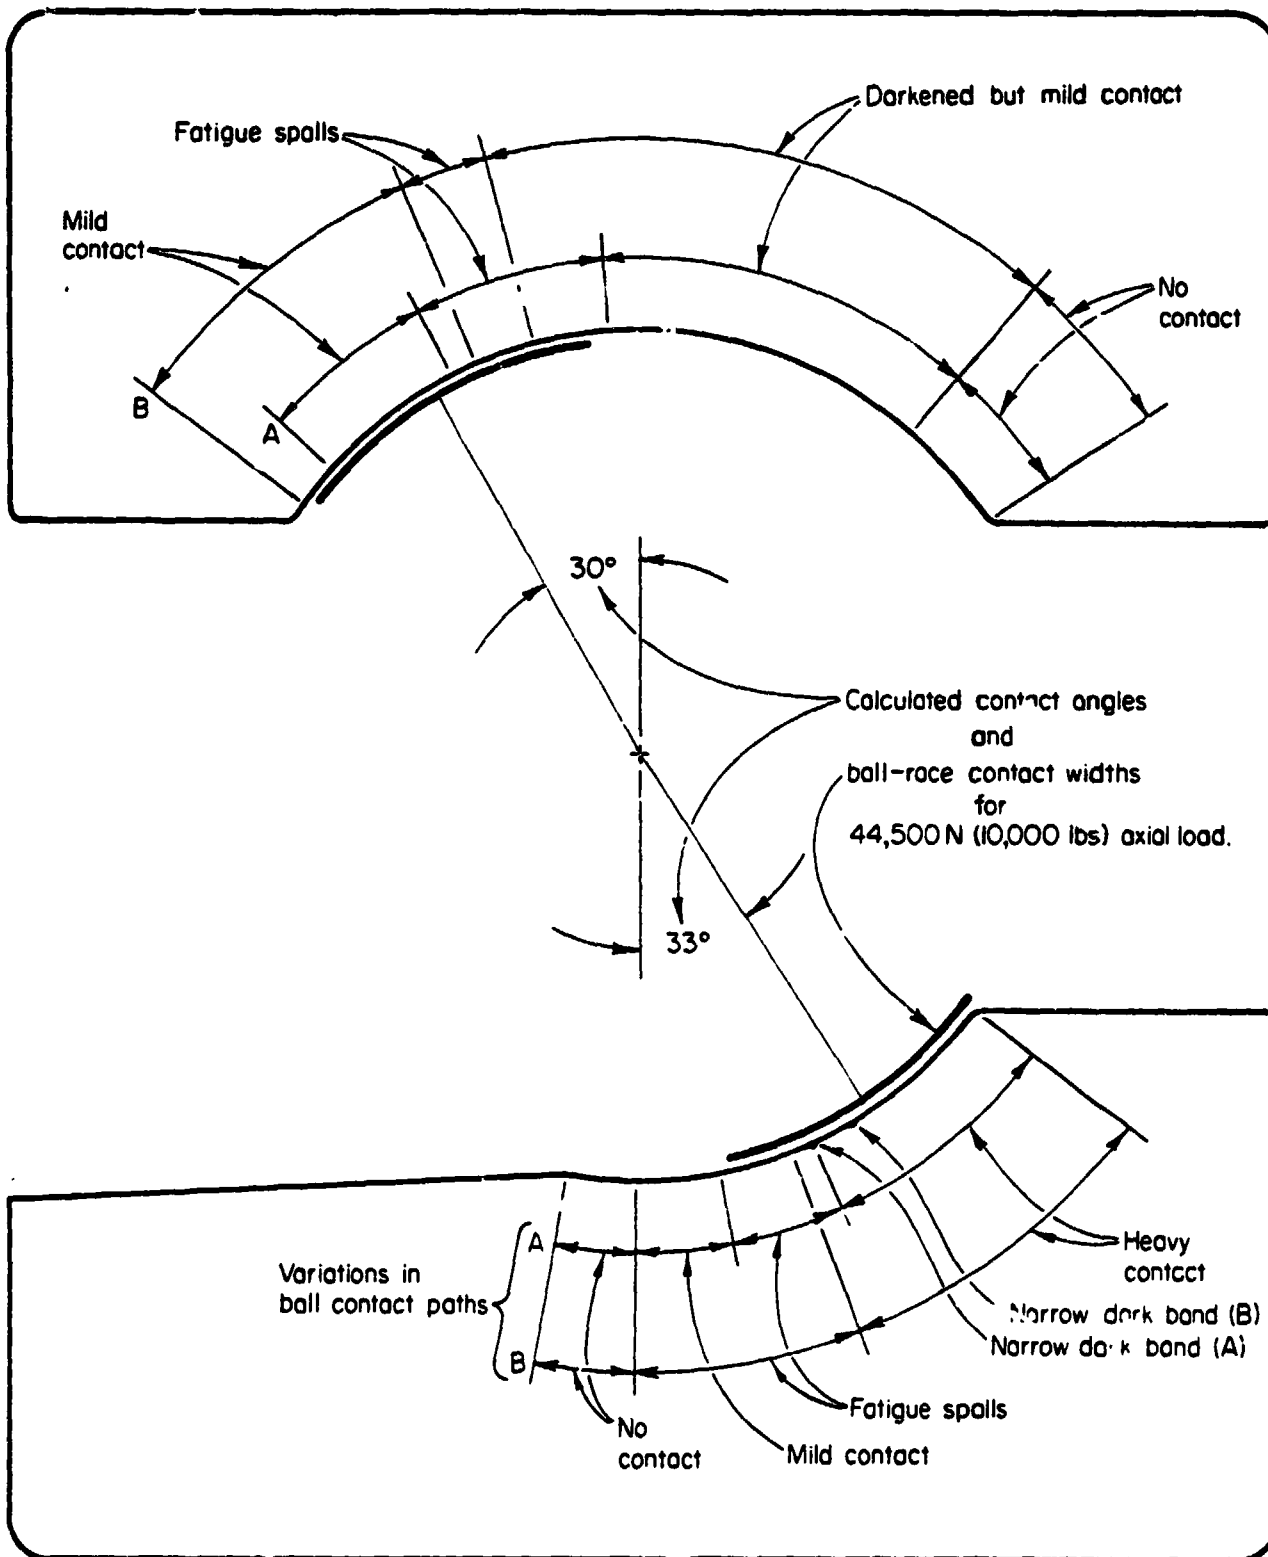
The measurements made during the bearing inspection of the location and width of the ball contact paths are presented graphically in Figures 12, 13, and 14. An estimation of the loads responsible for these paths was made by a series of BASDAP calculations. By graphical iteration, the load was chosen that gave the best simultaneous fit for both races of contact angle and race contact width. The contact conditions resulting from these loads are also shown in Figures, 12, 13, and 14. Bearing S/N 8549531 was apparently subjected to at least two major load conditions. The first, shown in Figure 12, was a high axial load of approximately 44,500 N (10,000 pounds). This load is responsible for the heavy wear and deformation of the inner race near the race shoulder.

FIGURE 12. LOCATION OF MEASURED BALL CONTACT PATHS ON BEARING S/N 8549531. CALCULATED CONTACT POSITIONS FOR A 44,500 N (10,000 POUNDS) AXIAL LOAD. (Positions "A" and "B" refer to location of extreme positions of ball contact paths.)

Based upon these findings, action must be initiated to reduce the applied bearing loads to levels within the bearing tolerance capabilities (the pump design loads are reasonable to obtain the necessary life from the bearings). Alternatively, if the source of the excessive loads cannot be identified or reliably controlled, design changes must be made to incorporate a bearing of sufficient size to withstand the high loads. The repeated experience of excessive loading on bearings from the turbopumps suggests that exercising at least one of these options will be critical to attaining the reliability appropriate for a SSME turbopump.

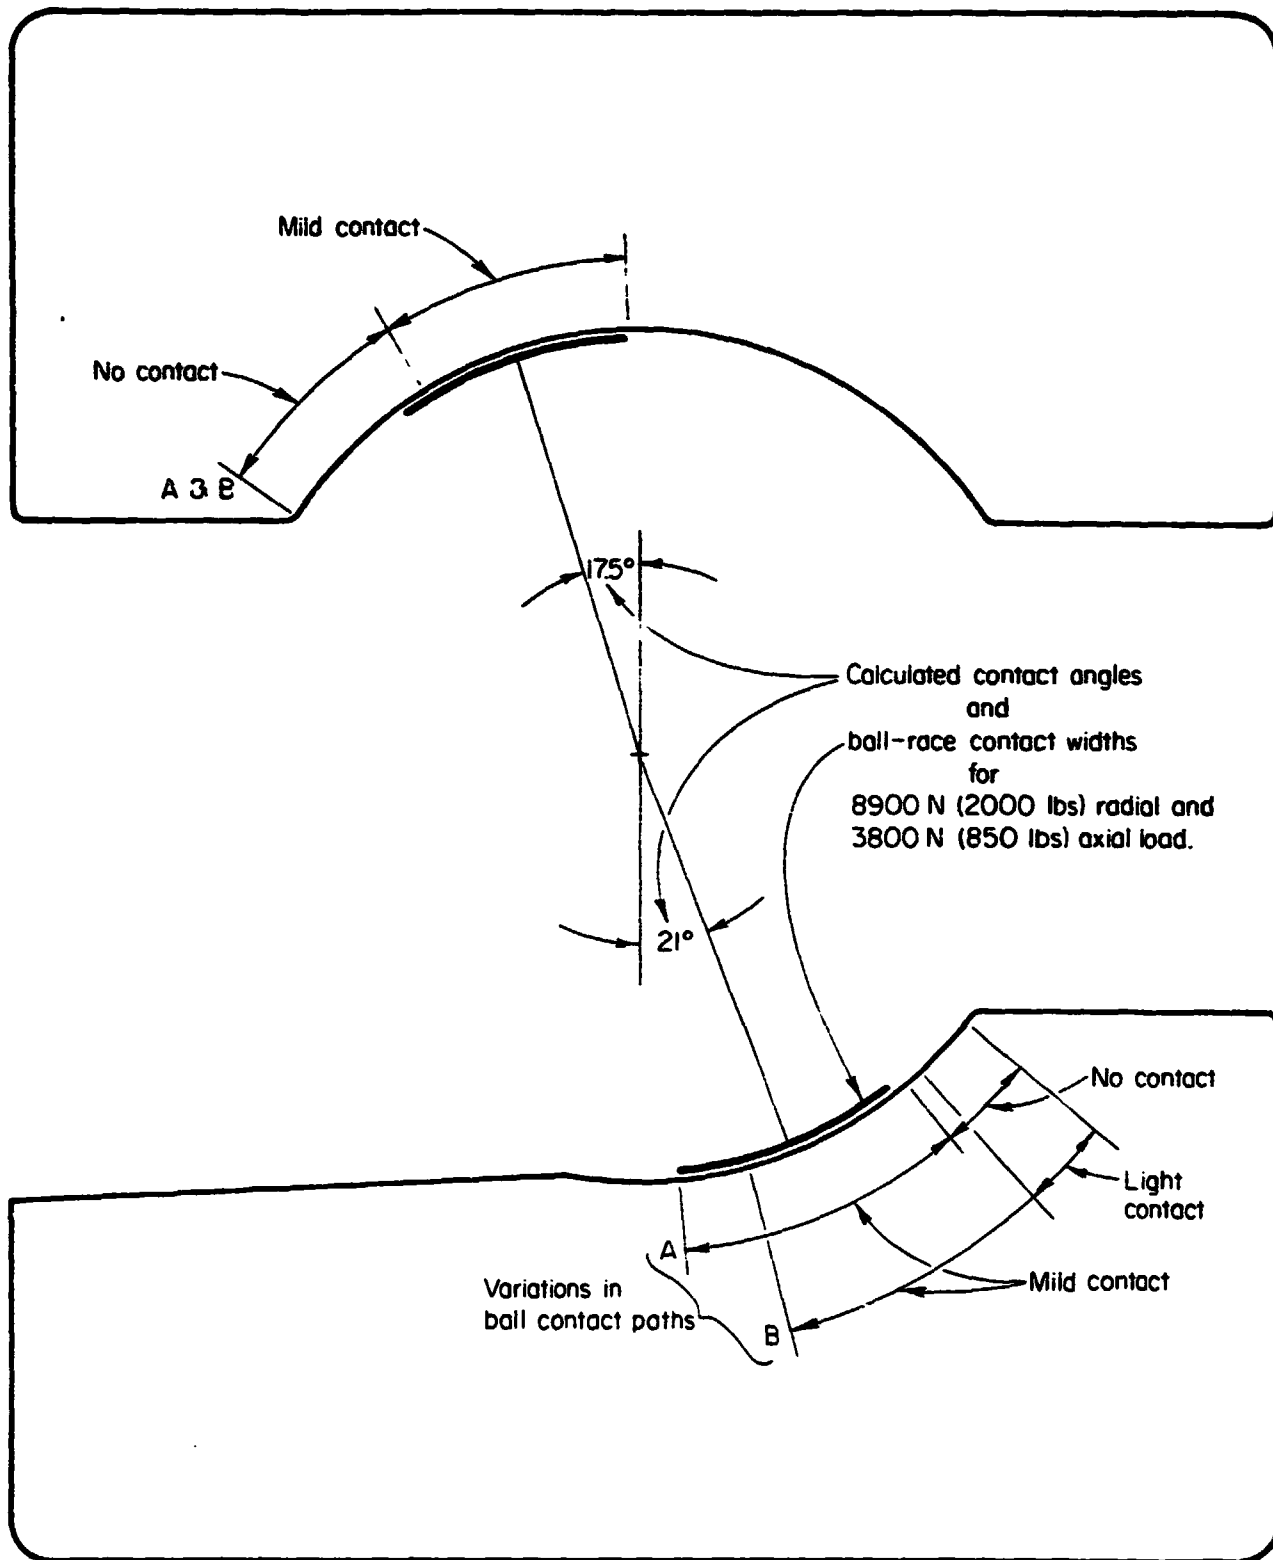
FIGURE 13. LOCATION OF MEASURED P.L. CONTACT PATHS ON BEARING S/N 8549531. CALCULATED CONTACT POSITIONS FOR AN 8900 N (2000 POUNDS) RADIAL LOAD COMBINED WITH A 3800 N (850 POUNDS) AXIAL LOAD. (Po = 1000 N) "A" and "B" refer to location positions of ball and contact.

The second loading condition, shown in Figure 13, consisted of an 8900 N (2000 pounds) radial load combined with a 3800 N (850 pounds) axial load. Since the contact paths from these two load conditions overlap at the location of the fatigue spalls, both loading conditions probably contributed to the fatigue failure. Intermediate loading conditions between those shown in Figures 12 and 13 may also have been applied to the bearing, but the overlapping contact paths do not permit a positive assessment of the possibility. The contact paths on bearing S/N 8549515 are best explained by a radial load of 8900 N (2000 pounds) combined with an axial load of 3800 N (850 pounds), as shown in Figure 14.

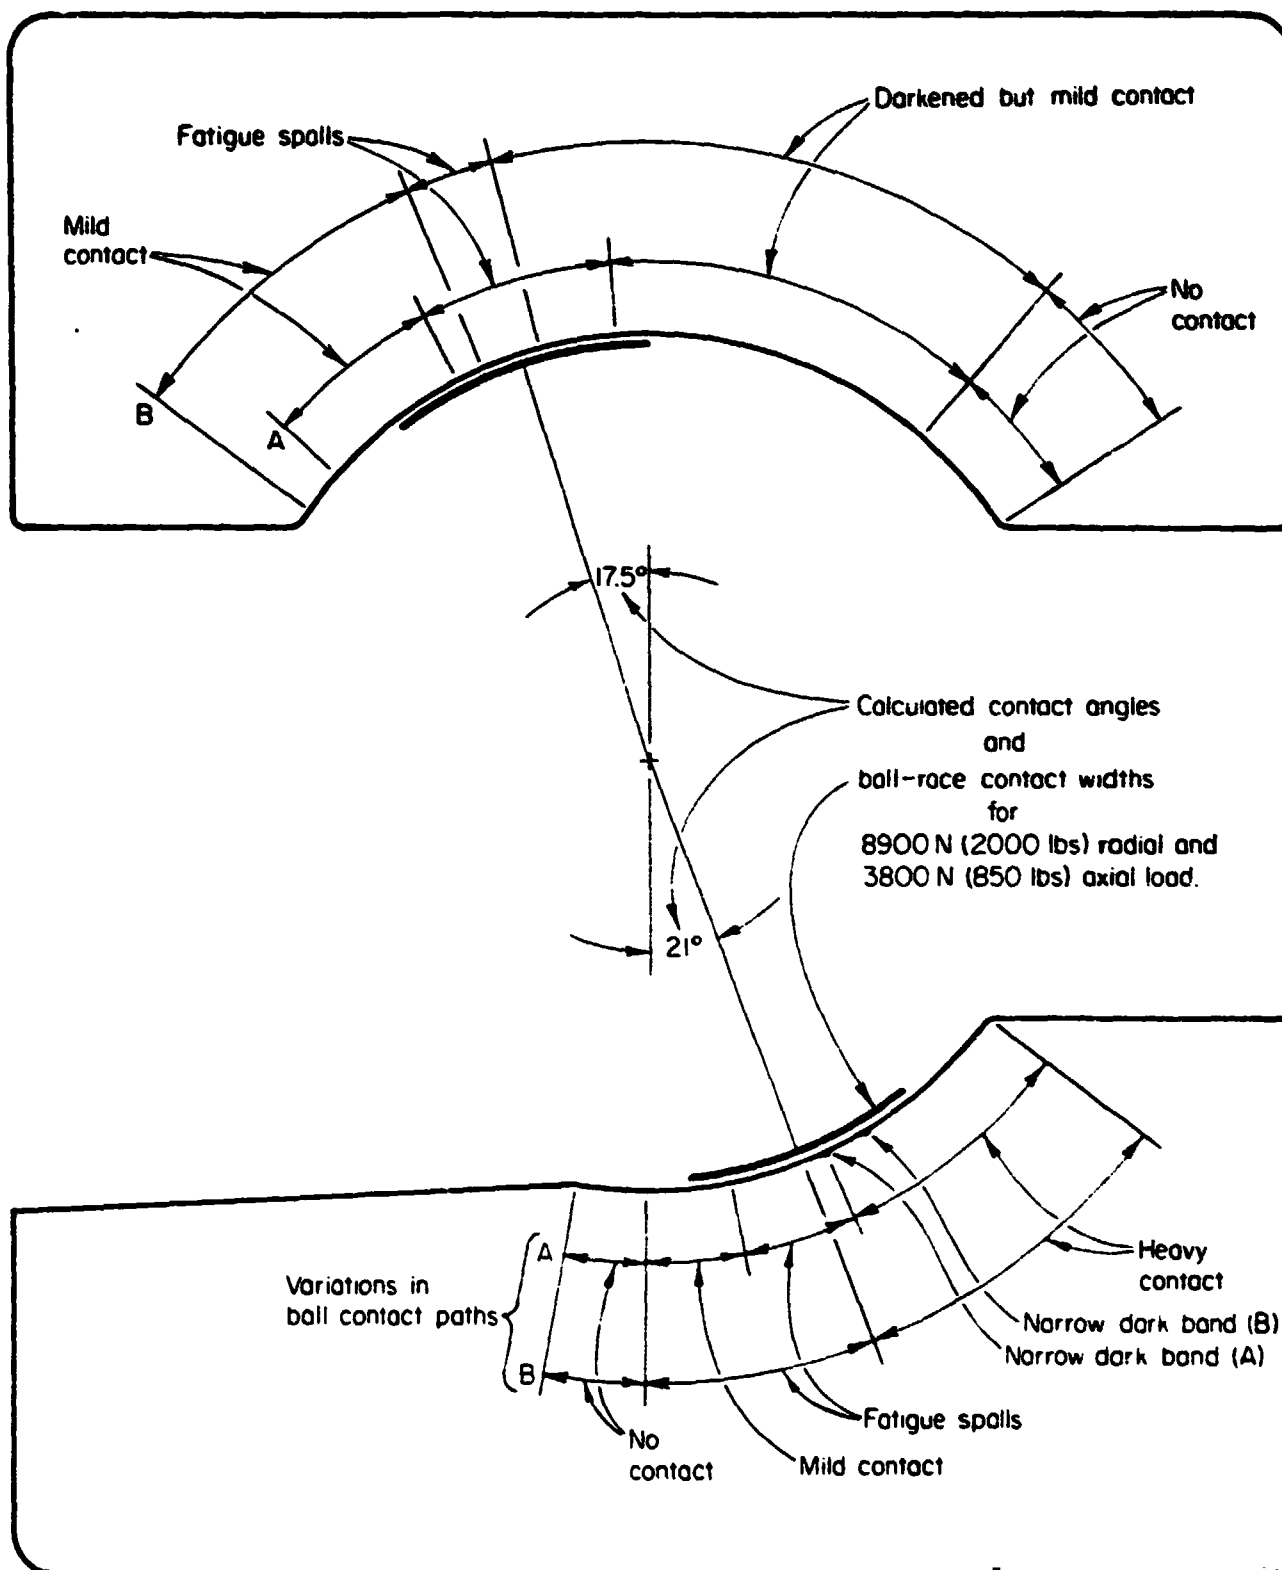
FIGURE 14. LOCATION OF MEASURED BALL CONTACT PATHS ON BEARING S/N 8549515. CALCULATED CONTACT POSITION FOR AN 8900 N (2000 POUNDS) RADIAL LOAD COMBINED WITH A 3800 N (850 POUNDS) AXIAL LOAD. (Positions "A" and "B" refer to location of extreme positions of ball contact paths.)
